Advanced Manufacturing Development of a Composite Empennage Component for L-1011 Aircraft

QUARTERLY TECHNICAL REPORT – NO. 13

This report is for the period 1 January 1979 through 31 March 1979

Lockheed Corporation
Lockheed-California Company
Post Office Box 551
Burbank, California 91520

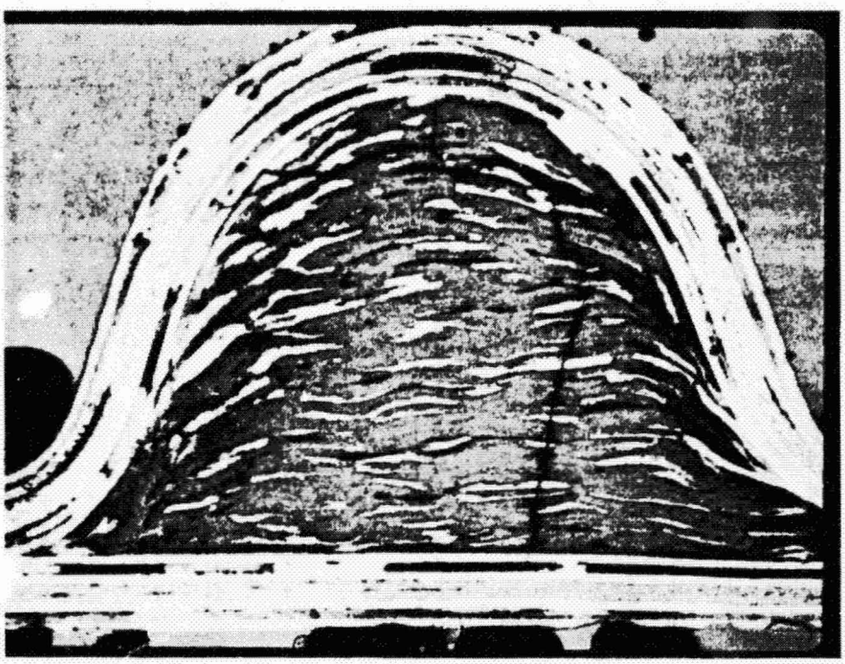
Rib development continued through January 1979 to focus on methods of making stiffening beads which were free of microcracks. The bead design upon which development effort had been concentrated is the "baseline" design which is a mass of all 0° fibers embedded centrally in the laminate. Various tooling and fabrication approaches were pursued in the attempt to provide a satisfactory bead. However, the best manufacturing effort, which is shown in Figure 3-3, still revealed cracking through the 0° fibers.

Figure 3-3. Microcracking Through 0 Degree Fibers in "Baseline" Stiffening Bead

Recognizing that the tendency toward cracking increased with the volume of 0° fibers in the bead, Engineering proposed alternate concepts for bead design. These concepts provided for moving some of the 0° fibers from the bead to the flange, and breaking up the amount of these fibers in any single grouping. See Design Concept "C" in Figure 3-1.

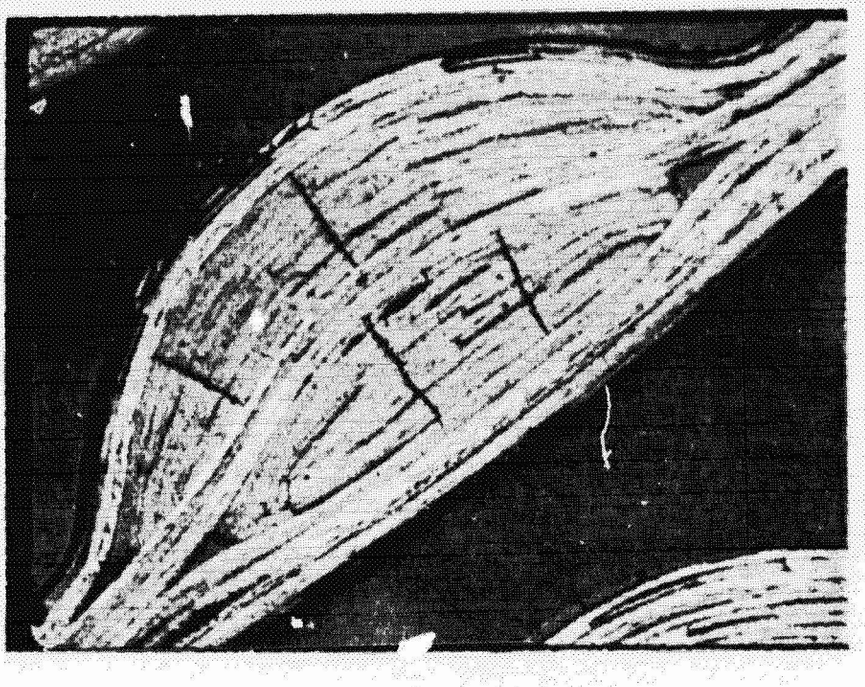
Figure 3-6 and 3-7 show that cracking occurred in both beads, and the beads flattened and spread.

Figure 3-6. Bead Molded in Tool Cavity

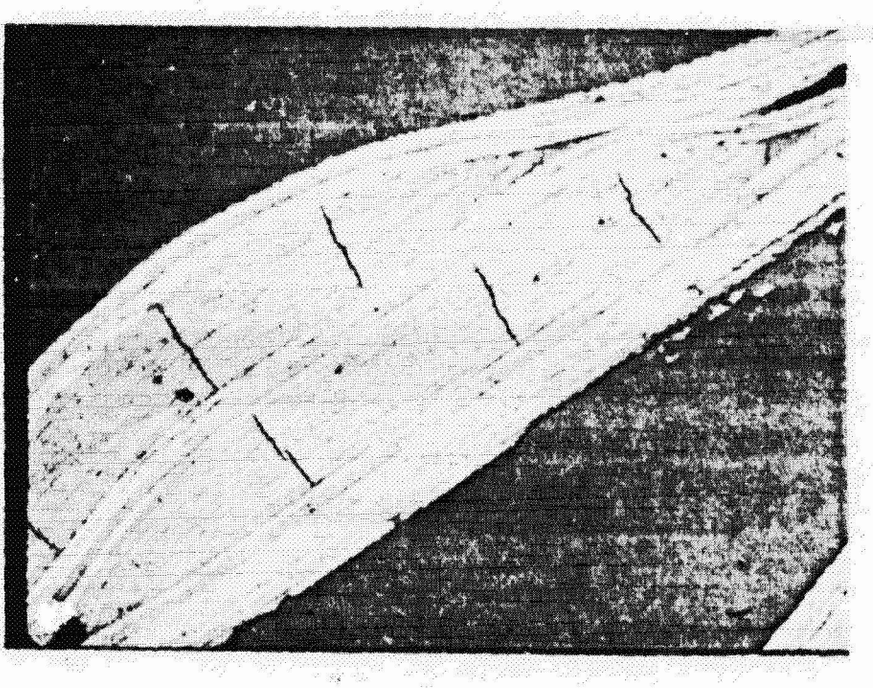
Figure 3-7. Bead Molded Under Vacuum Bag

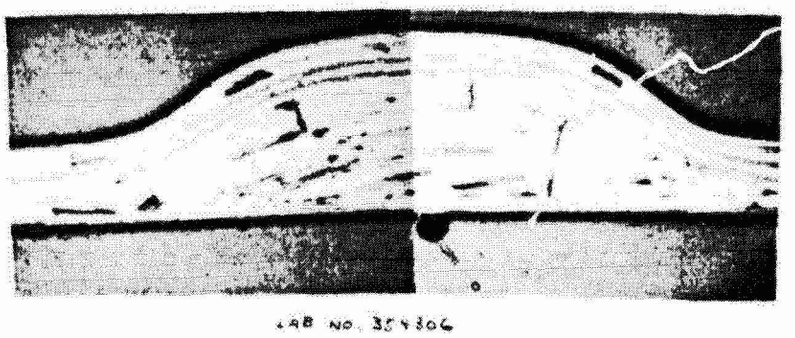
Figure 3-10. Microphotograph of Concept "D" Bead Showing Cracks Through the 0°Plies

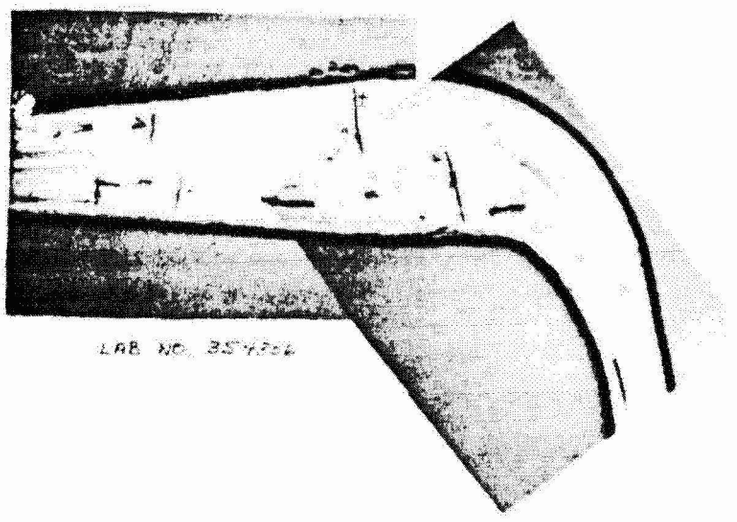
Figure 3-11. Microphotograph of Concept "D" Flange Showing Cracks Through the 0°Plies

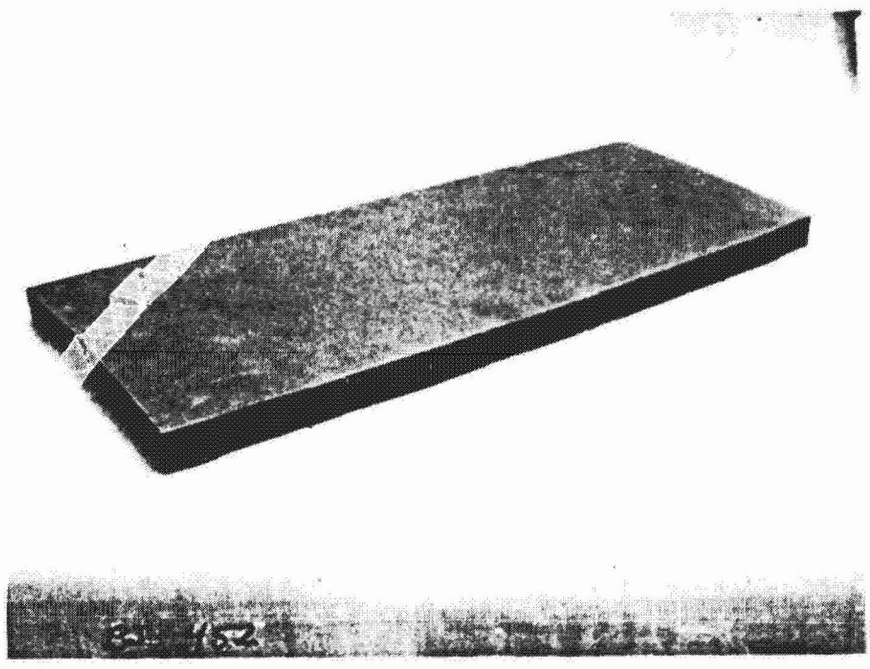
Figure 3-18. Solid Web Rib Made with Syntactic Resin Core

Two development parts were molded to this configuration. The first part is seen in Figure 3-18. Quality Assurance confirmed acceptable resin content, specific gravity, short beam shear, and compressive strength values. An ultrasonic scan detected voids in an area near the flanges next to the trailing edge. Microphotos validate the scan. These voids were caused by the silicone bag which did not fit over the part correctly.

Both parts exhibited some bow and twist after cure. Investigation into the cause and cure of this condition is in progress.

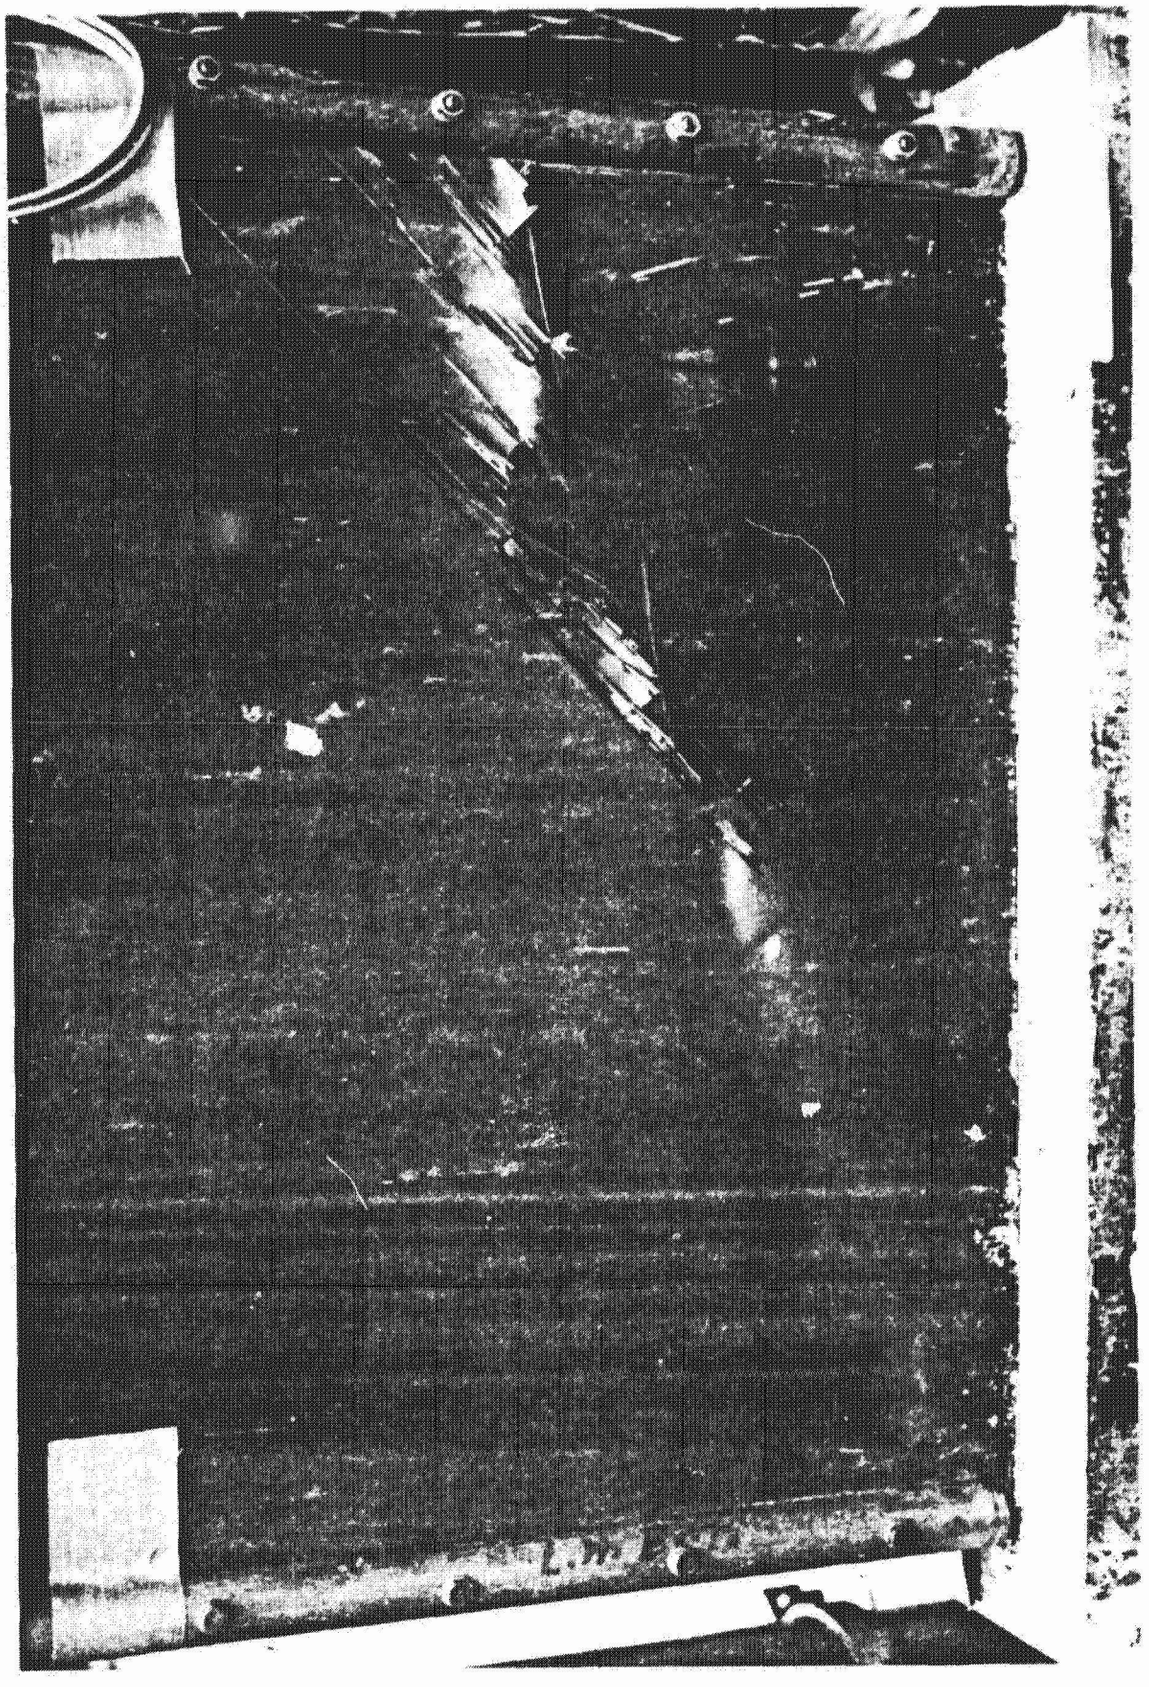
Failure occurred in the lower bay of the 3-bay panel. Examination of the panel indicated that a skin/hat separation had occurred with subsequent rapid failure of the hats and skins shown in Figures 4-8 and 4-9. The failure is considered to be fixture induced as the end potting introduces a bending moment due to the built in effect. The damaged area will be cut off and the specimen will be retested in a different configuration to find the true failure load.

Figure 4-9. Closeup of Skin Side Failure

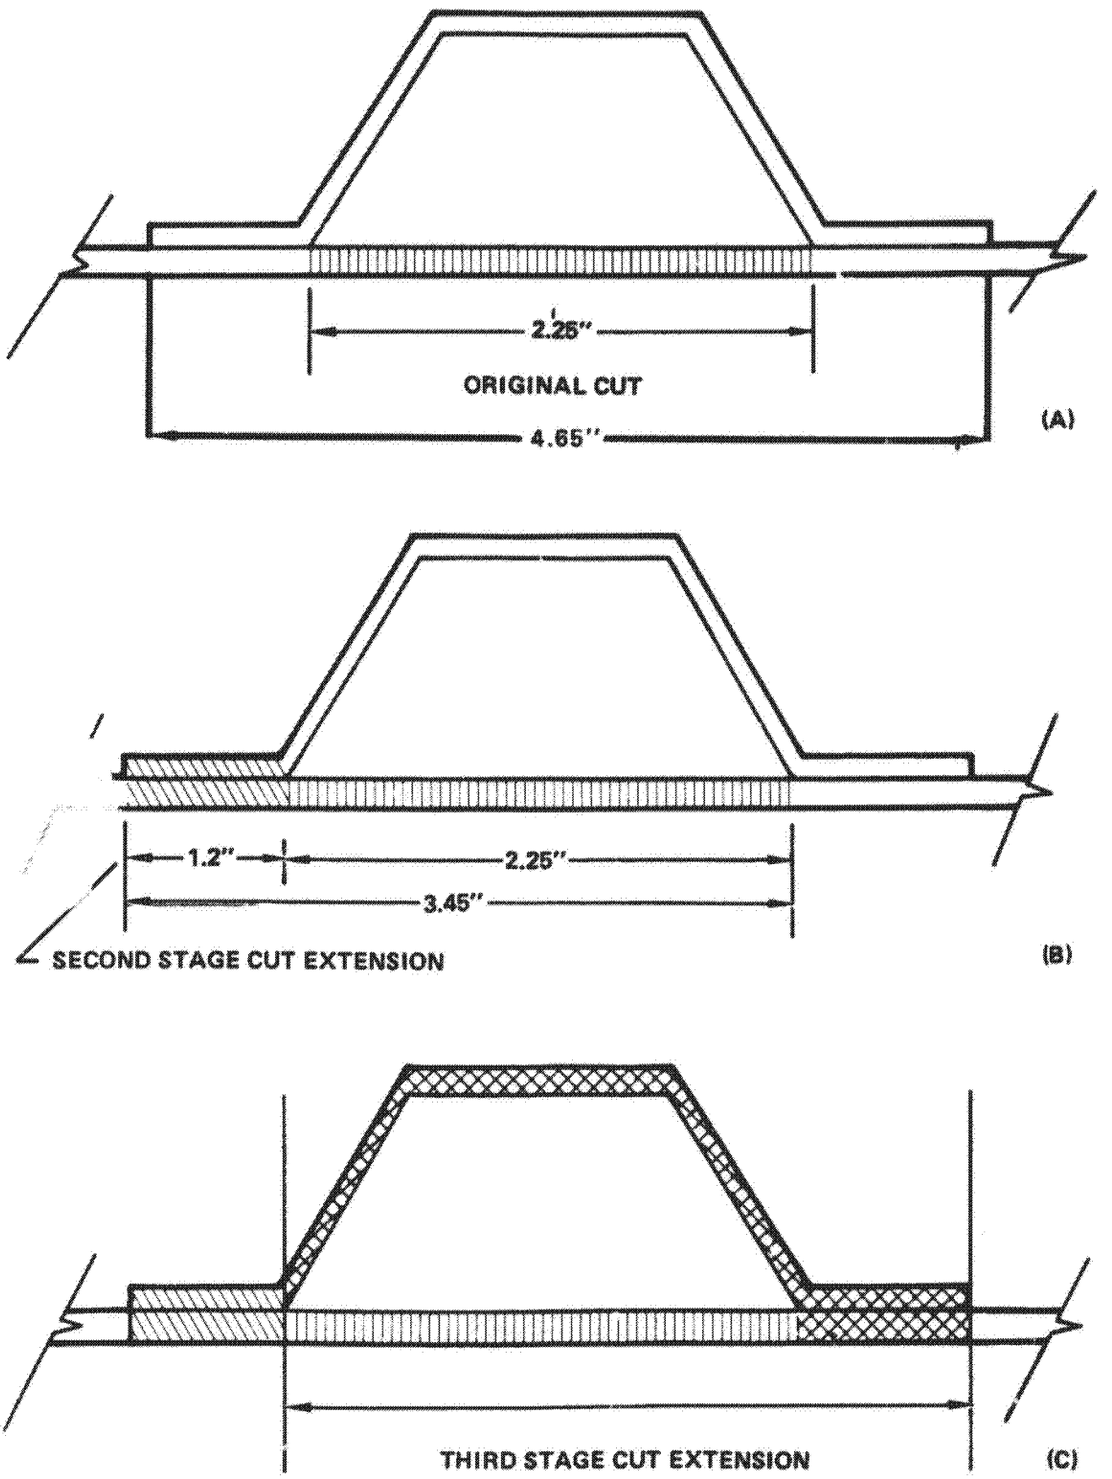
Figure 4-11. Panel Saw Cut Stages

After completion of the full lifetime (36,000 flights), the saw cut was extended completely through the hat including the crown and both flanges as shown in Figure 4-11c. The spectrum loading was then continued for an additional 1/2 lifetime. Only minor crack growths were noted.

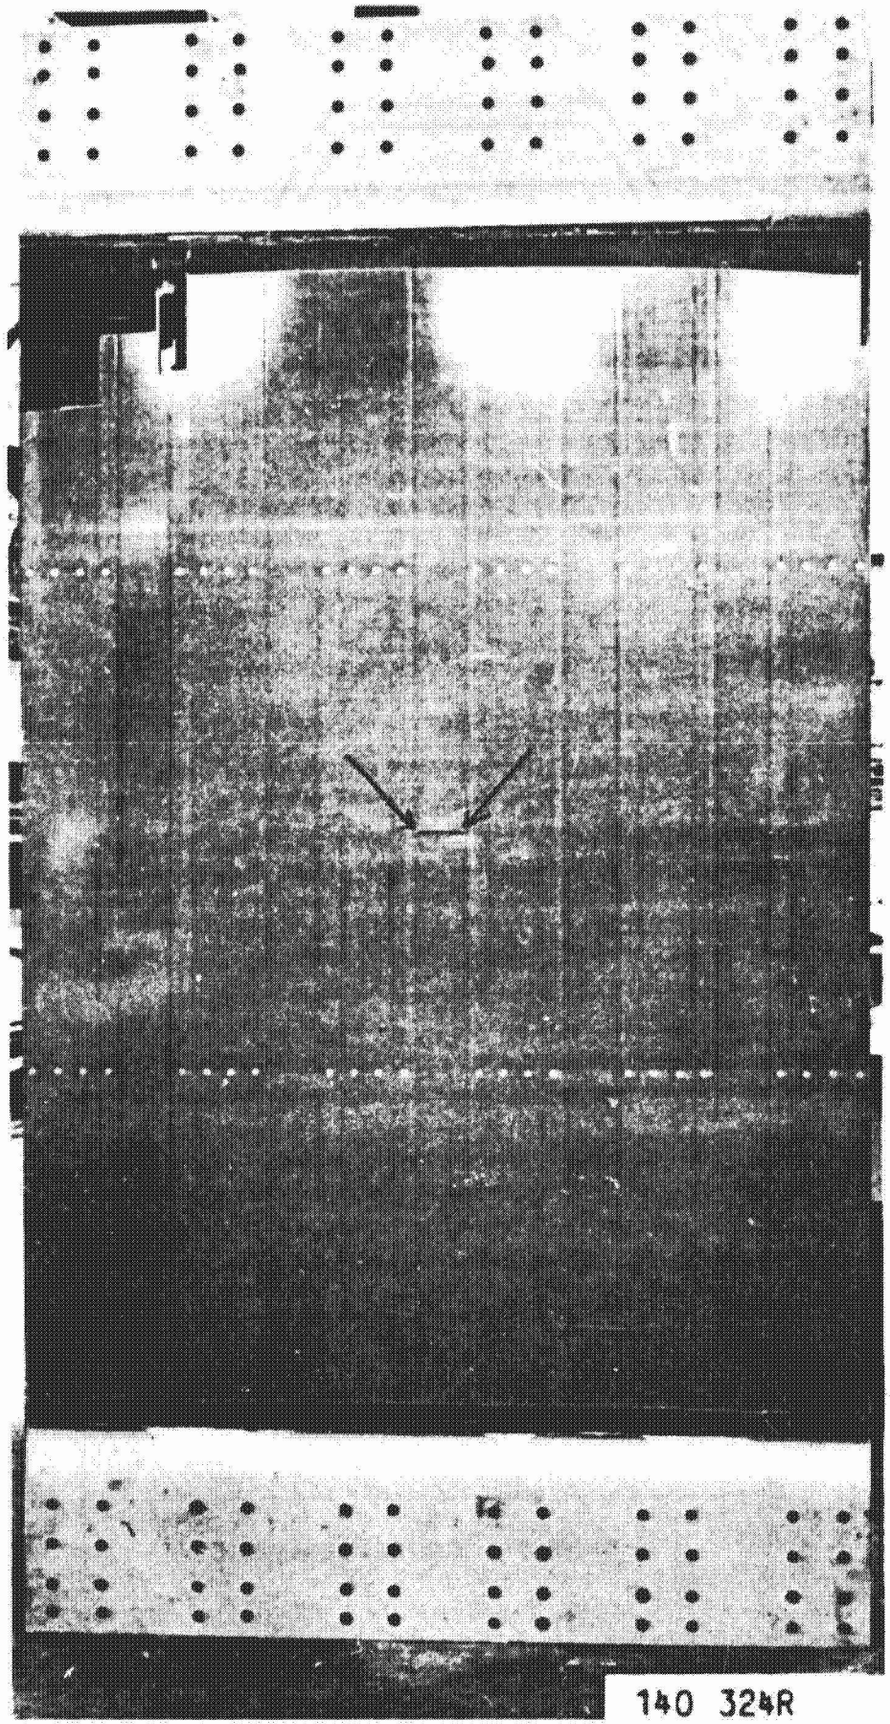
Figure 4-12. Saw Cut Under Center Hat

After the 1/2 lifetime (18,000 flights) the limit load cycles were applied. A loud "pop" was audible and visual examination showed that cracks had developed in two areas: (1) at the end of the saw cut in the skin, 3 cracks 1/8 to 3/16 inches long; and (2) in the hat side wall at the region of the saw cut intersection. The skin cracks were examined ultrasonically and were found to be surface delaminations only. The hat cracks and damage were confined to the side wall of the hat in an area about 3/8 inches in diameter. The flight-by-flight spectrum was again initiated for another 1/4 lifetime. During the first 1800 flights of this sequence, the crack on the hat sidewall grew to the crown of the hat and stopped. No further growth was noted for the duration of this run other than some minor surface layer fiber delaminations. Also noted were some minor amounts of surface fiber lifting at countersunk fasteners between Bays 2 and 3. The spectrum testing was continued for an additional 1/4 lifetime (full lifetime total) with no change in growth noted. Up to this time 2 cycles of limit load had been applied to the specimen.

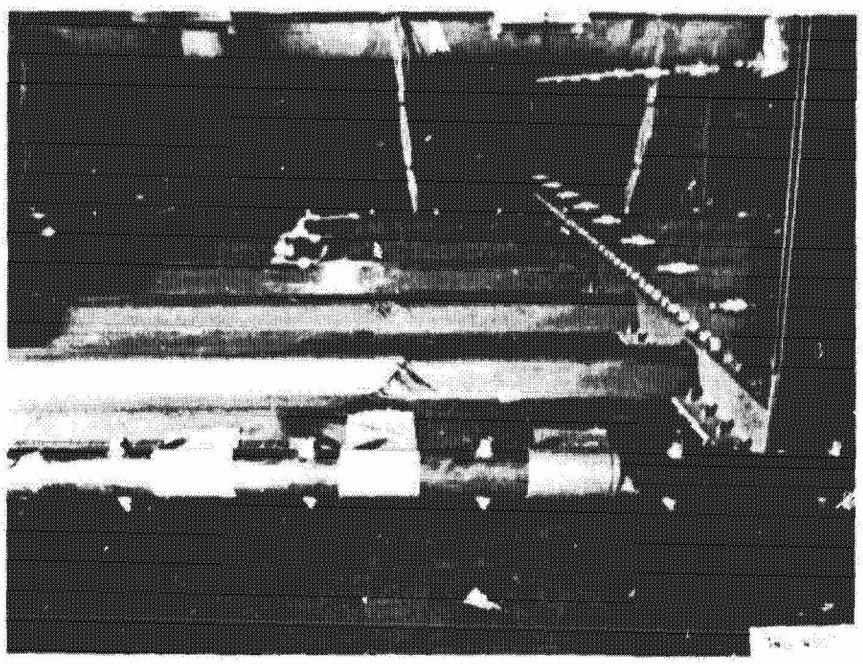
After completion of this sequence, the limit load cycles were again applied. Failure of the panel occurred at 96% of limit load in compression. Figures 4-16 and 4-17 show the panel after failure. The panel had carried 100% of limit load in tension and was in the limit load compression cycle at failure.

The test demonstrated that the cover can withstand one-half lifetime of fatigue loading and can carry limit load with obvious partial damage. The panel in fact sustained one-and-a-half lifetimes of fatigue and two applications of limit compression and three applications of limit tension. Failure in the compression mode was due to the high stress concentration at the end of the saw cut which was a tenth-inch wide. Local surface delaminations at these ends precipitated failure.

Figure 4-16. Stiffener Side After Failure

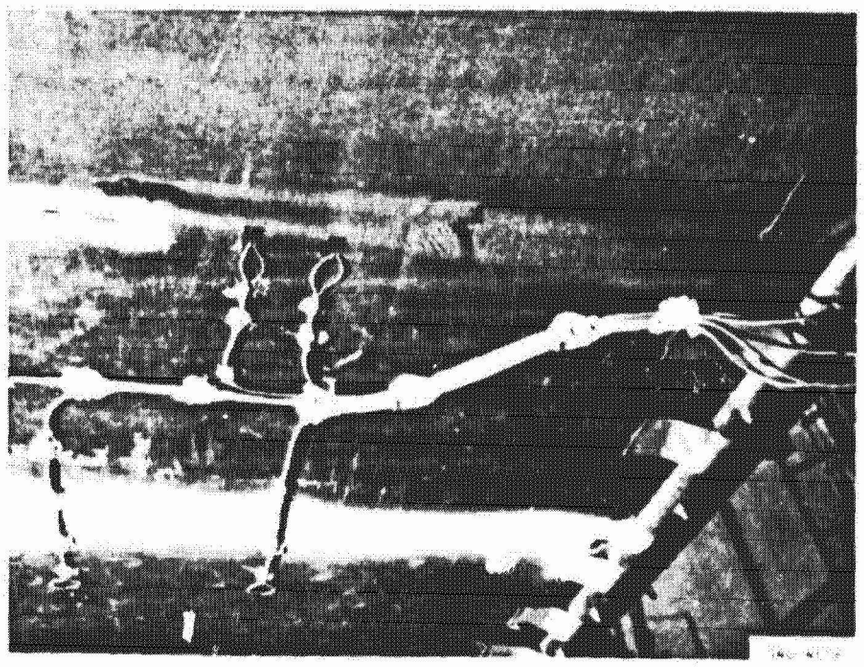
Figure 4-17. Skin Side After Failure

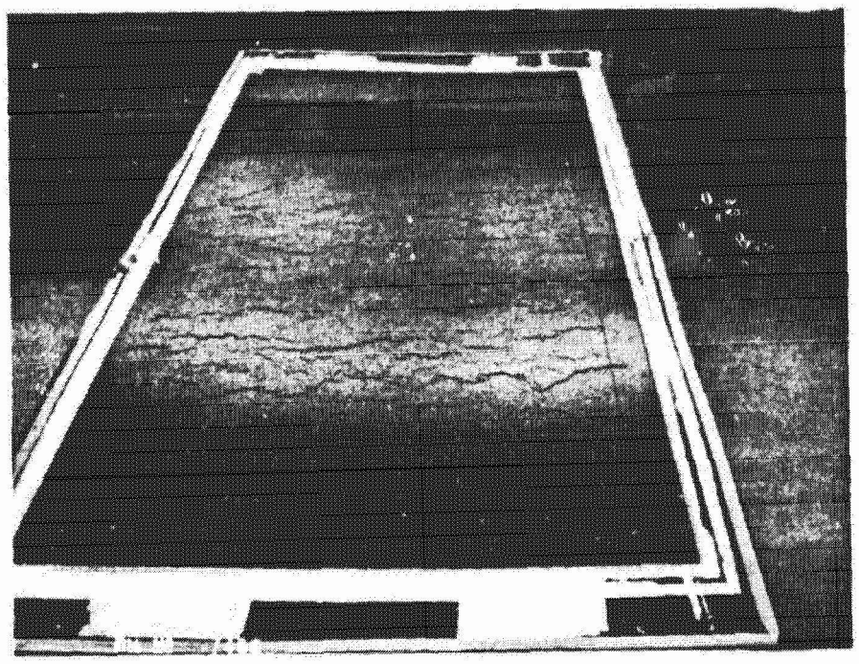
(c) Wrinkles following the contour of doubler sections or tapered sections

Figure 7-1. Typical Wrinkled Panel

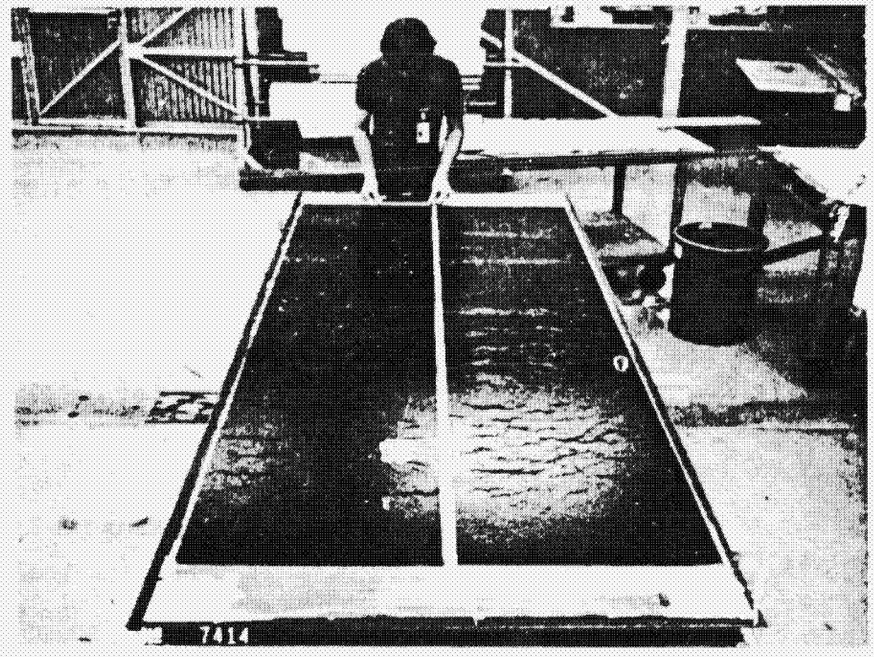
Since it was evident that all wrinkles were removed during final cure and that laminates containing 16 or more plies were essentially free of wrinkles the ancillary test cover specimens were fabricated using the single stage prebleed of the skin and hats prior to final curve. With these larger laminates, up to 80 ins. long and 16 or more plies thick some minor wrinkling was evident prior to final cure. All wrinkles disappeared during the final

Figure 7-3. Wrinkled Prebled Panels Prior to Combining and Curing

cure and no ill-effects were noted either in NDI or in the destructive testing. The components fialed generally as predicted, at or close to the predicted loads.
